# **Thermal Patterns Created By Moisture Accumulation Within Exterior Masonry Walls**

**Antonio Colantonio, Garry Desroches  
Public Works And Government Services Canada**

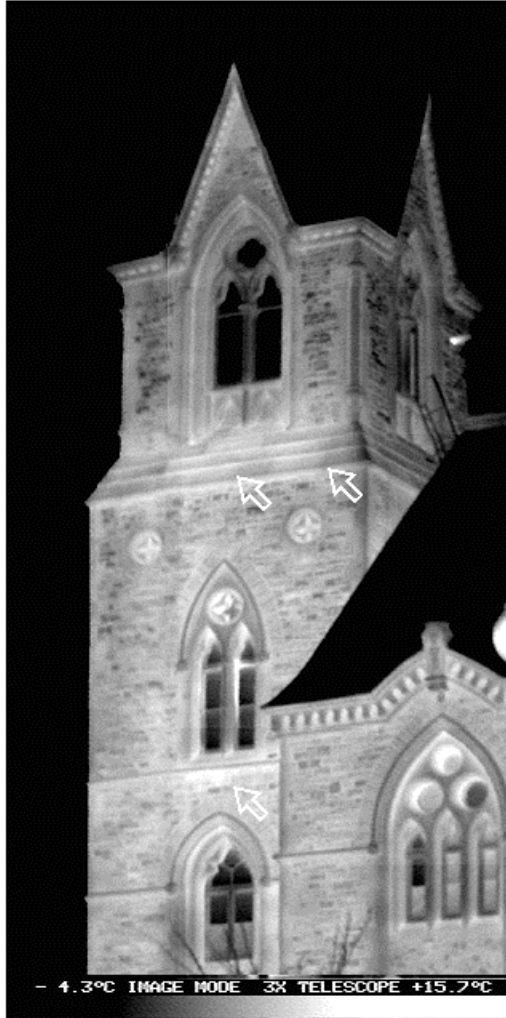
*Figure 1. Neutral Building Pressure (0 Pa),  $T_o = -8^\circ\text{C}$ , No precipitation or snowfall for at least 7 days prior to inspection.*

Rainwater penetration patterns are generally associated with the top section of walls and most likely around parapet walls. Unless buildings are located in areas with a high driving rain index, most building only experience rainwater penetration along the top floors. Other areas where rainwater penetration may occur are at sloped or protruding walls or drainage planes from upper wall sections. Window sills and parapets are examples of such drainage features. Sloped relief details in stone masonry walls are another example of such conditions. (Refer to *Figure 1*)

Sloped areas on stone and masonry walls are areas that attract melt water throughout the winter months. Often these areas are also characterized by staining and dirt build up created by the surface water accumulation. In many of the building investigated there was a correlation between the dirt build up on stones and moisture accumulation within the wall and the specific stones.

*Arrows point to suspected moisture accumulation within the limestone cladding due to rain and melt water throughout winter months.*

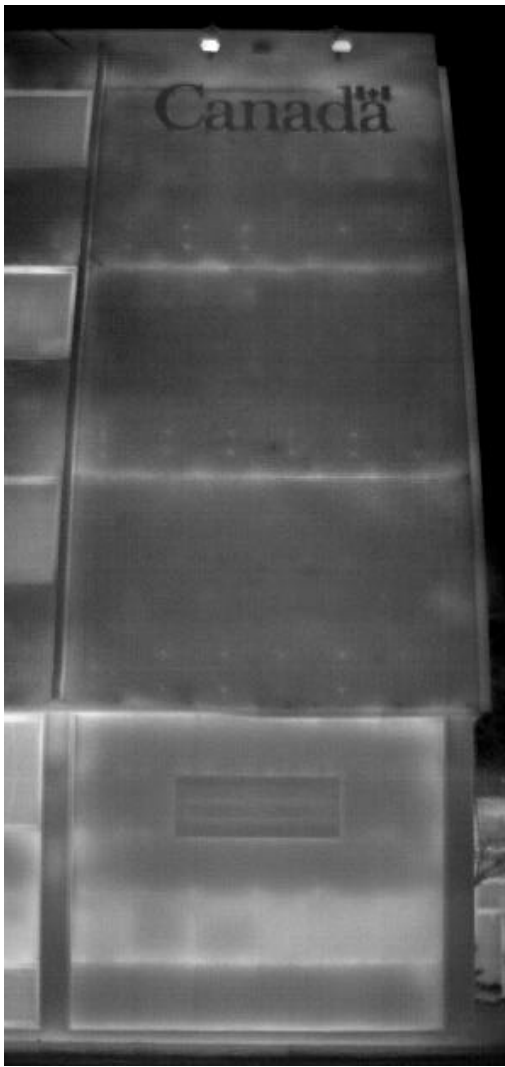
*Figure 2. Negative Building Pressure (-140 Pa),  $T_o = 0^{\circ}\text{C}$*

The two images below (*Figures 2 & 3*) demonstrate the amount of moisture accumulation that can occur within masonry cladding as a result of stack effect brought on by low winter exterior ambient temperatures. Both images taken during negative building pressures are void of air exfiltration patterns but *Figure 3*, taken at a lower ambient temperature ( $-11^{\circ}\text{C}$ ), displays greater amount of moisture accumulation within the masonry cladding at the top of the building than *Figure 2* taken at temperatures approximately  $10^{\circ}\text{C}$  higher.

The only other variable in this image is significantly increased negative pressure in the higher temperature situation that could have resulted in slightly modifying existing moisture patterns. The increased negative pressure combined with the time prior to inspections that this condition existed may have reduced the amount of moisture within the wall cladding. In addition, due to reduced exterior ambient temperatures, stack effect would have been reduced for the period prior to capture of image in *Figure 2*, thus reducing the amount of moisture especially at the top of the building envelope.

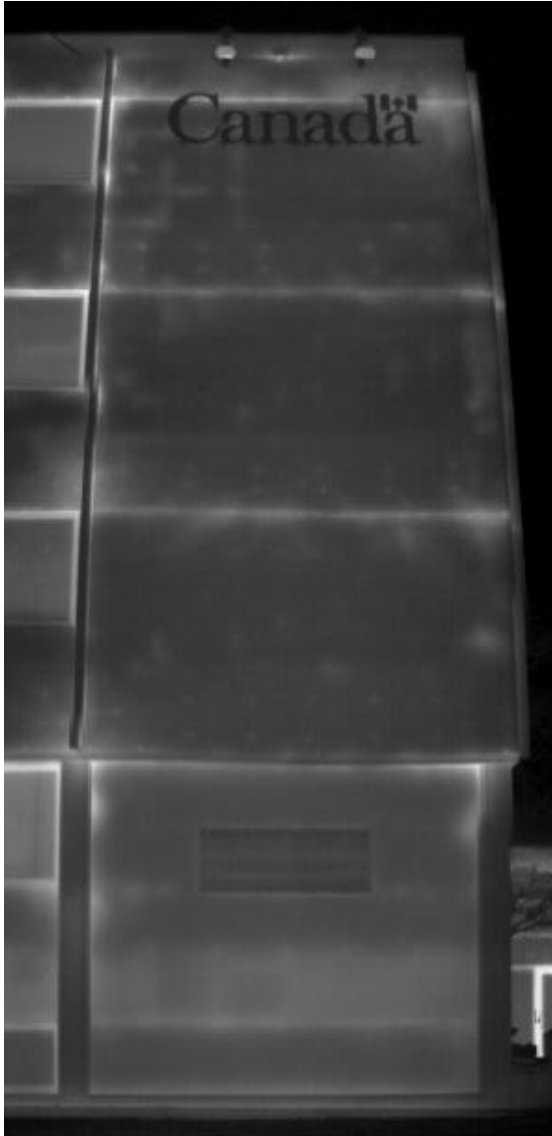
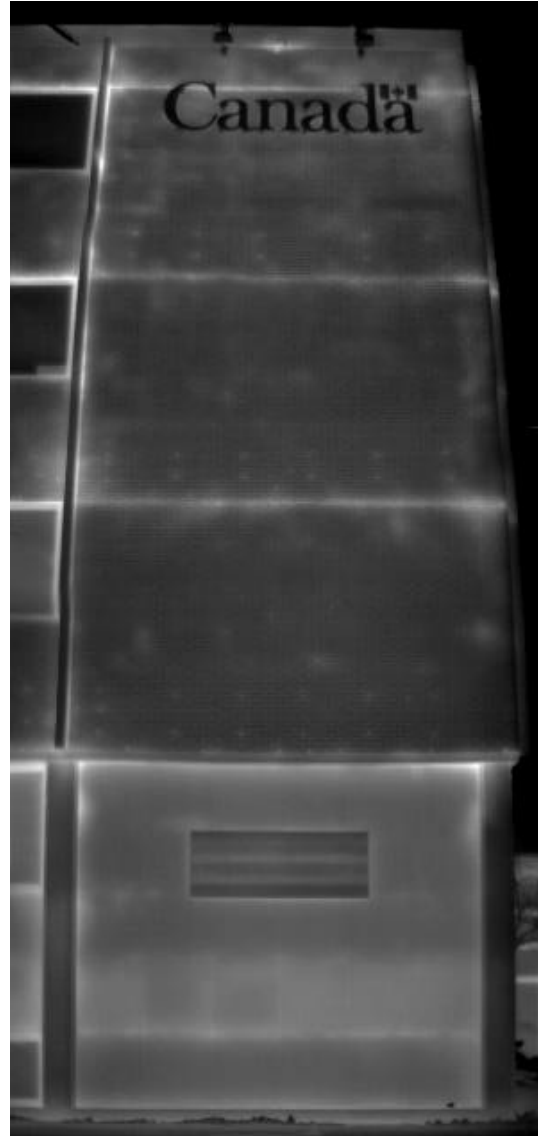
**Figure 4.** Positive Building Pressure (+40 Pa),  $T_o = 0^\circ\text{C}$       **Figure 5.** Positive Building Pressure (+25 Pa),  $T_o = -11^\circ\text{C}$

The two images in **Figures 4 & 5** above demonstrate the amount of moisture accumulation that can occur within masonry cladding as a result of stack effect brought on by reduced exterior ambient temperatures. Both images, taken during positive building pressures, display thermal patterns created by air exfiltration patterns in addition to previously accumulated moisture patterns due to stack pressures. These air leakage patterns overpower the moisture induced thermal patterns in both exterior ambient temperature conditions.

The image taken at the lower ambient temperature illustrates greater amount of moisture accumulation within the masonry cladding than the image taken at temperatures of approximately  $10^\circ\text{C}$  higher. This is consistent with the thermal patterns produced during the negative building pressure inspections. The only other variable in this image is slightly increased positive pressure in the higher temperature situation that could have resulted in the slight modification of existing moisture patterns.

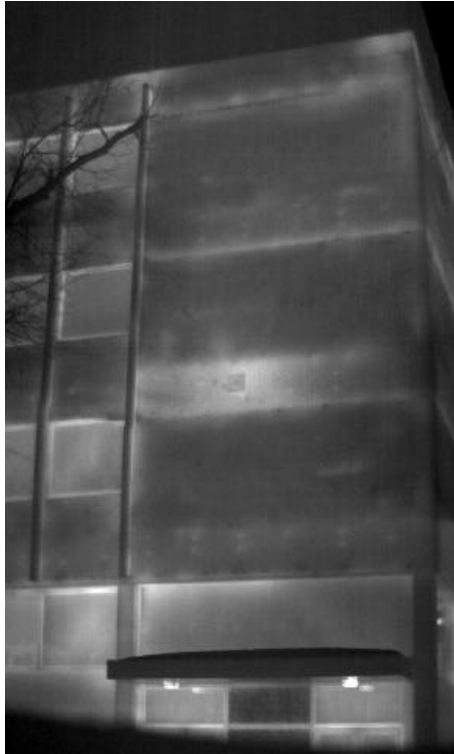
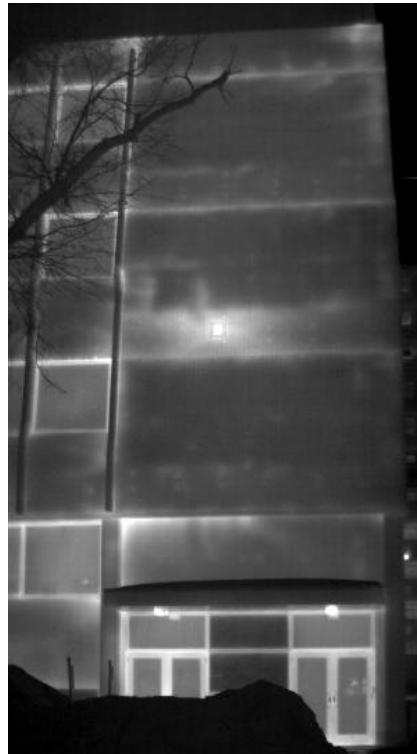
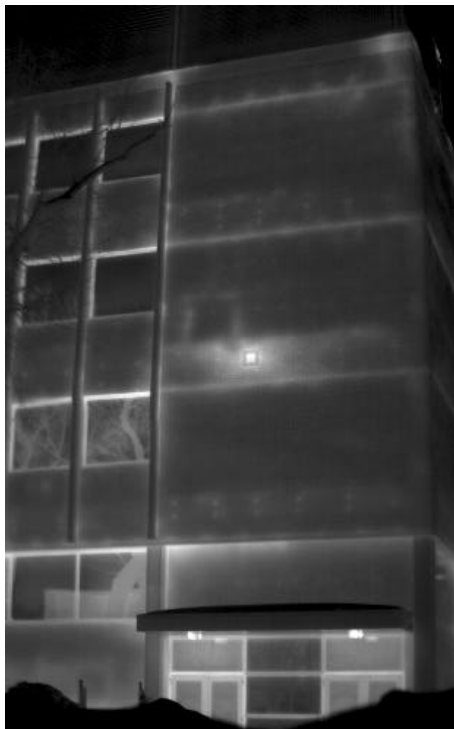
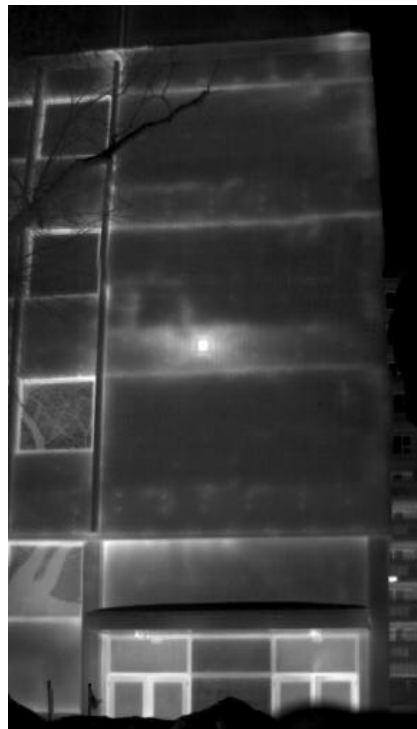
*Figure 6. Negative Building Pressure (-140 Pa),  $T_o = 0^\circ\text{C}$*

*Figure 7. Positive Building Pressure (+40 Pa),  $T_o = 0^\circ\text{C}$*

*Figure 8. Negative Building Pressure (-140 Pa),  $T_o = -11^\circ\text{C}$*

*Figure 9. Positive Building Pressure (+40 Pa),  $T_o = -11^\circ\text{C}$*

The thermal images seen in *Figures 6 to 9* demonstrate the variances between moisture patterns created by both direct and diffuse air leakage. These images also illustrate the variations during both positive and negative pressure conditions during inspections.

Moisture patterning is most visible during negative building pressure inspections since air leakage patterns do not overpower those created by moisture within the cladding or insulation. If conducting inspections within an hour or so after initializing negative building pressure, then moisture patterning created by normal operating conditions become most visible in the infrared. Moisture patterning appears to be more apparent in areas where diffuse air leakage occurs through the exterior walls rather than at areas where direct air leakage occurs during these inspections. One possible explanation for this phenomenon is that in diffuse air leakage conditions, moisture has a greater potential to get trapped into porous materials rather than in situations where direct air leakage occurs from the interior to the exterior. What has been generally observed is that moisture accumulation around areas of direct airflow paths occurs at the peripheral areas of the openings and not immediately at their locations. Again heat and air flow from the exfiltrating air generally will not allow for moisture retention at the immediate opening but rather some distance around the openings where there is less air flow to move the moisture further out of the cladding materials. In very cold conditions ( $-30^{\circ}\text{C}$  and lower), visual signs of hoar frosting is visible at these problem areas.

Pre-existing moisture patterning does not seem to be affected to any degree during positive pressure inspections other than to make them less apparent due to the much warmer surface temperatures created by the exfiltrating air at openings within the air barrier assembly. Positive building pressure inspections will result in additional moisture deposition within the wall assembly and thus create additional areas of moisture accumulation within the wall area that may not be present during normal operating conditions of the building. Both significant pressure (between 50 to 150 Pa) and considerable duration (greater than 4 hours of positive pressure) are required before additional moisture patterning is visible due to positive building pressure conditions in building with average to above average leaky air barrier assemblies.

When looking at buildings during cold weather conditions, variations in the thermal signatures created by naturally occurring conditions will take considerable time to be modified and in some conditions, may not be modified at all. In *Figures 6 to 9* the masonry areas around the vent located in the central section of the third floor appears warm even in the negative pressure inspections even through negative pressures were imposed for more than 2 hours prior to each inspection. Exterior ambient temperature seems to have little affect on the dissipation of stored heat and moisture within the masonry around these locations. In these conditions, greater time is required under negative building pressure to eliminate the stored heat from air leakage within the masonry cladding.

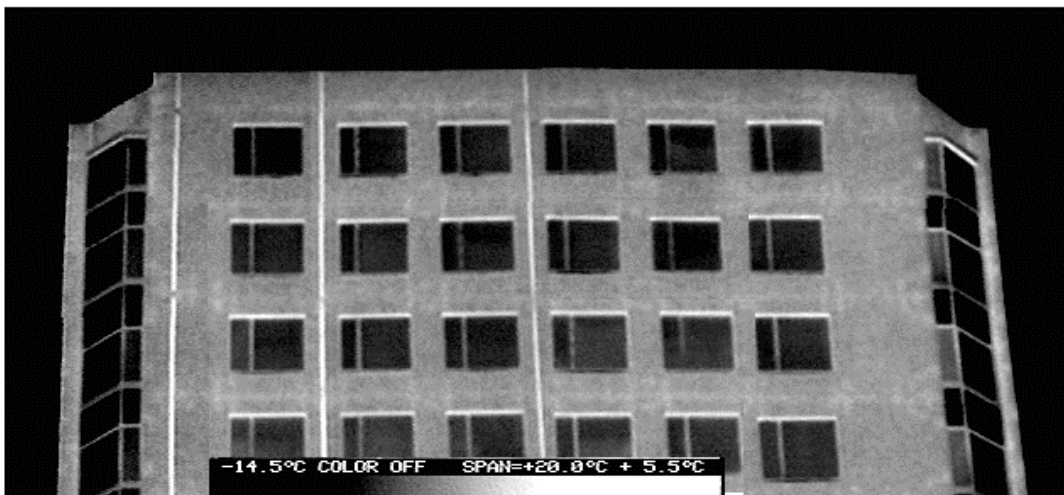
*Figure 10. Negative Building Pressure (-60 Pa),  $T_o = -7^{\circ}\text{C}$ , maintained for a duration of 4 hours prior to inspection.*

The composite thermal images in *Figures 10 & 11* were taken on subsequent mornings with *Figure 11* positive pressure imagery produced 24 hours prior to the negative pressure imagery. The arrows at the parapet walls of this 24-storey building identify the moisture accumulation within the brick cladding as a direct result of positive building pressure imposed on the building for test purposes. The moisture patterns were not present prior to the positive building pressure being induced into the building and did not appear until after 4 hours of positive building pressure.

*Figure 10* illustrated the thermal imagery from the same area of this building while being subjected to negative building pressure the following evening. Note that the thermal patterns due to air leakage are absent from this image as are the patterns created by the moisture accumulation within the brick cladding at the upper sections of the elevation. The thermal bridging patterns are still evident. This image indicates that moisture accumulation, as with heat build up due to excessive air leakage, given a full 24-hour time period, will dissipate when the driving force of the heat and moisture accumulation within the cladding is not present.

Therefore when conducting exterior large building infrared thermographic inspections during cold winter months, it is advised to conduct the negative building pressure inspection prior to the positive building inspection **IF** both are planned for one evenings work. If the work is spread out over a number of days, then either inspection can be carried out first since the resultant moisture accumulation from internal sources will be allowed to dissipate due to solar gain and natural diffusion of moisture to outdoors through the cladding material.

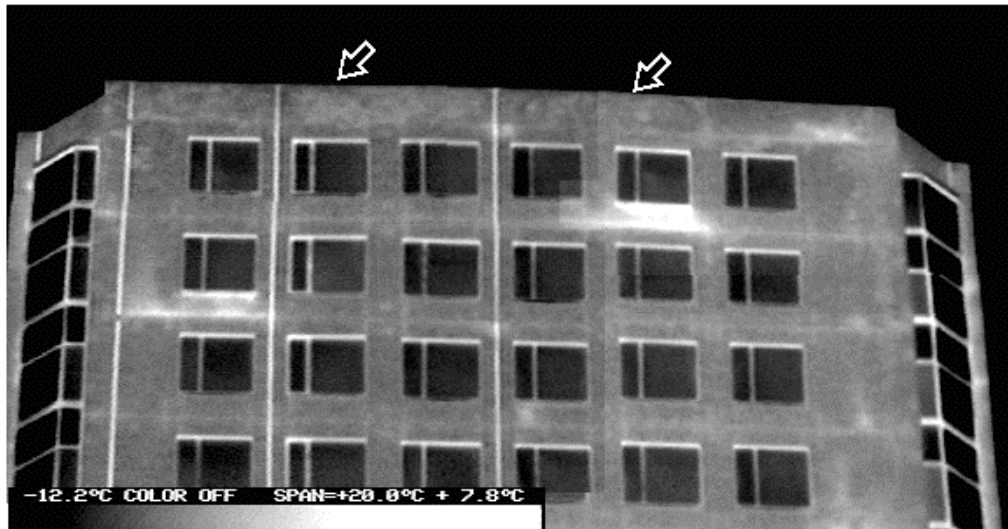
*Figure 11. Positive Building Pressure (80 Pa),  $T_o = -7^\circ\text{C}$ , maintained for a duration of 5 hours prior to inspection.*

As seen in *Figure 11*, leakage areas were random in various section of the building and were not wide spread, but the sustained abnormal positive building pressure during testing did result in additional moisture migration from the building into the masonry cladding. This is a common occurrence in both solid as well as cavity wall assemblies. In cavity wall assemblies, moisture migration often travels from the source of the air barrier opening up to the top sections of the wall cavity due to convection cycles and thus moisture patterns appear more pronounced at the top section of wall cavities and building elevations. Another factor that contributes to the increased build-up of moisture accumulation at top sections of building is the increased stack effect pressures generally found at these elevations during winter months.

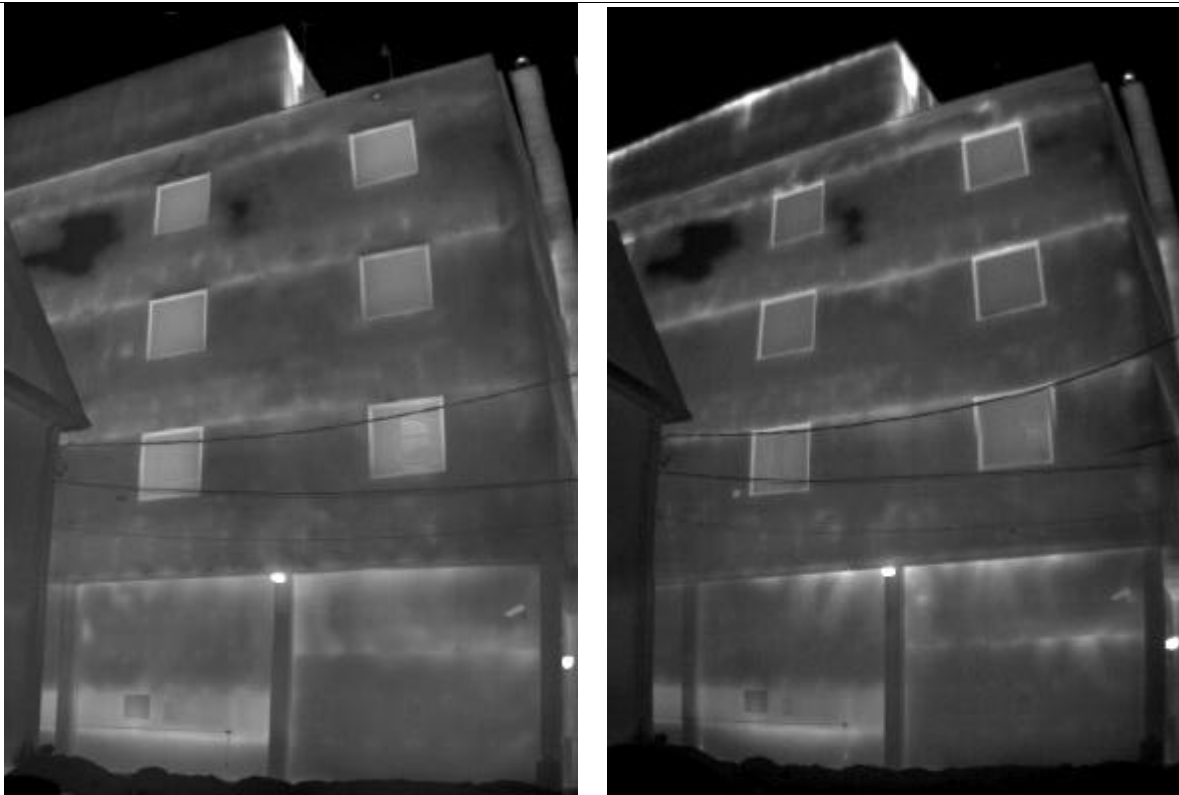
**Figure 12.** Negative Building Pressure (-140 Pa),  $T_o = 0^\circ\text{C}$     **Figure 13.** Positive Building Pressure (+40 Pa),  $T_o = 0^\circ\text{C}$   
Both images taken during same evening, 4-hour time span between the two images.

The dark areas on the 4<sup>th</sup> floor masonry illustrate the thermal pattern generated by the phase change of masonry moisture. It appears reasonably consistent during both the negative and positive inspections of this building during the same evening. Note the cold areas above the window heads on the third and fourth floor windows typical of air leakage into the building during negative building pressure conditions.

The moisture patterning within the wall due to accumulated moisture over the winter months appears warm around the floor slabs and is present during both the negative inspections as well as the positive pressure inspections. During the positive building inspection, these moisture patterns appear to be overpowered by the thermal patterns created by the air leakage through the walls from the building interior.

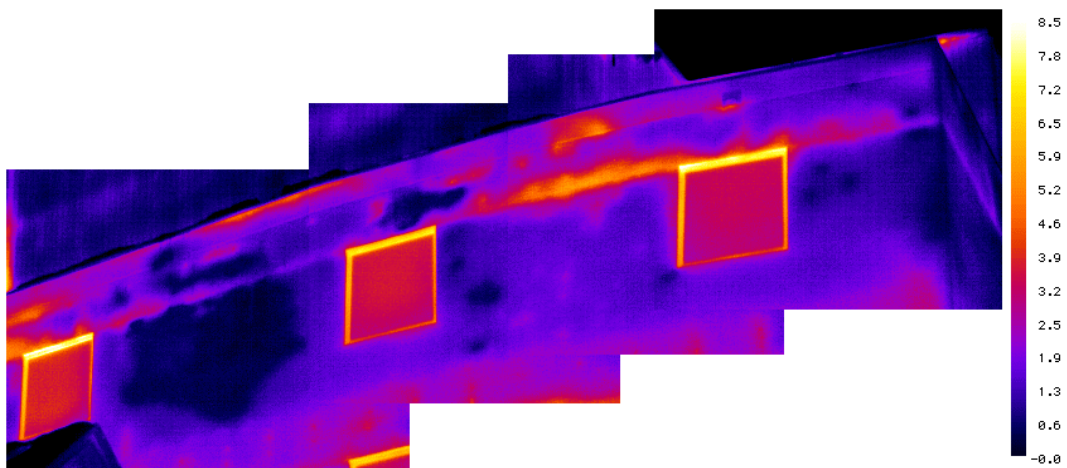
Phase change of moisture within porous cladding materials from a liquid to a solid occurs at temperatures slightly below freezing. In these conditions frozen surface moisture is visible through reduced surface temperatures. This phenomenon occurs independent of either positive or negative pressures. The accompanying thermal images in *Figures 12 to 14* illustrate this point.

**Figure 14.** Positive Building Pressure (+3 Pa),  $T_o = -1^\circ\text{C}$ , Close up thermal Image of previous images in **Figures 12 and 13** showing phase change of moisture within masonry. This image was taken a year earlier than previous images but generates the same type of imagery.

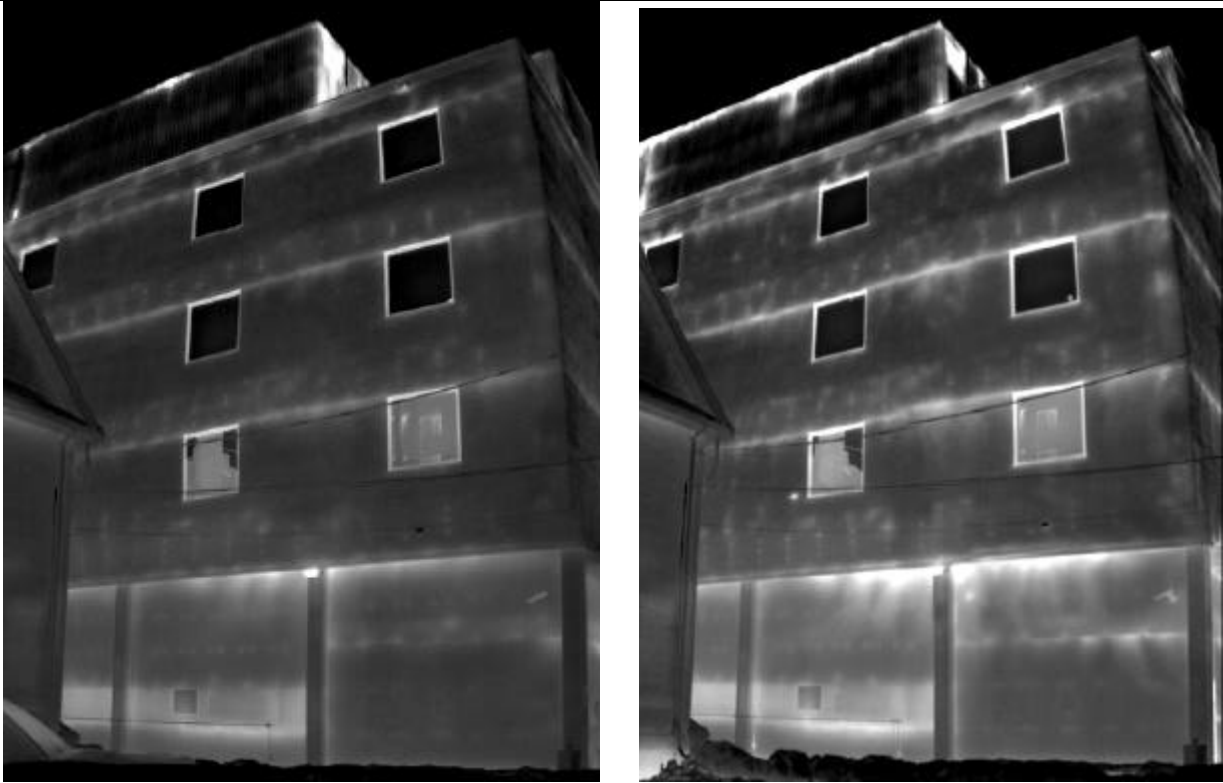
**Figure 15.** Negative Building Pressure (-8 Pa),  $T_o = -11^\circ\text{C}$     **Figure 16.** Positive Building Pressure (+25 Pa),  $T_o = -11^\circ\text{C}$

Both images were taken during same evening, 4 hours between the two settings. Due to the lower exterior ambient temperatures, phase change phenomenon is not visible at low outside temperatures. Moisture accumulation is visible during both inspections, but more during positive building pressure inspections than slightly negative pressure inspections
