Case Study: Carleton Lodge – Recladding for a Better Environment

Tom Sinclair, P.Eng – Halsall Associates Limited
Ashok Malhotra, P.Eng. – Halsall Associates Limited
Brea Williams, Ph.D, P.Eng. – Halsall Associates Limited

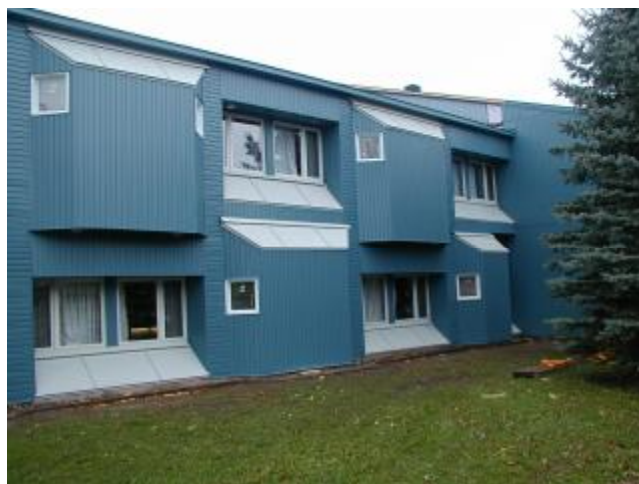
Figure 2: Retrofitted Building Elevation

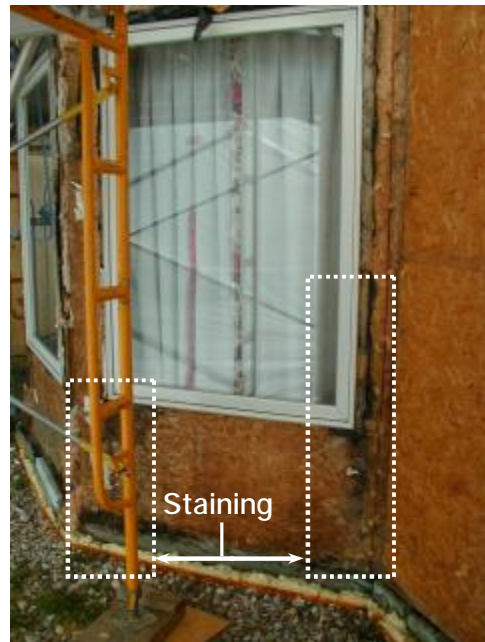
With no soffits, attics had isolated vents in the soffit over the second floor windows. Attic ventilation was poor and icicles formed. Due to lack of an adequate overhang, roof runoff fell to the ground either directly along the wall or by cascading over the shed roofs over the residential washrooms. Some of this water infiltrated the wall assembly through vulnerable areas at the shed roofs, windows, and joints in the siding, and backsplash at the base of the wall (Figure 3). Moisture also infiltrated the wall cavity from the building interior due to spillage of water in bathrooms, leakage from plumbing pipes, and condensation on pipes and exhaust ducts. Condensation in the exterior wall due to high interior humidity was most critical in the common assisted bath areas, where the majority of the fans were not functioning, and not vented to the building exterior. Whenever mould has been encountered since the building was completed, the City of Ottawa (and formerly the Regional Municipality of Ottawa Carleton) has taken immediate action to remove and remediate and conducted frequent air testing to ensure residents and staff were safe.

Figure 3: Stained Sheathing Around Windows

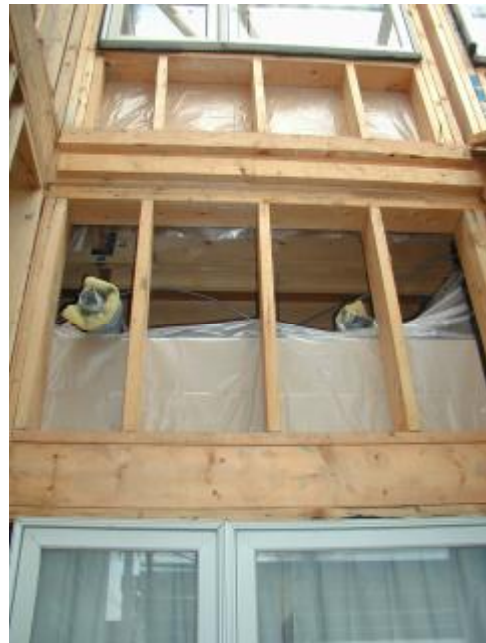
The walls were reconstructed by removing all exterior siding, sheathing and batt insulation. Repairs to the existing 6-mil polyethylene vapour barrier could not be completed due to complexity in the exterior wall design (Figure 4). Since a comprehensive air barrier could be constructed, all efforts were taken to ensure that it was achieved. A new redundant air barrier was constructed with sealed sheathing and a high permeance membrane. The high permeance membrane also acts as a secondary moisture barrier. Batt insulation in the stud cavity was replaced. Based on dynamic hygrothermal modelling by WUFI, additional rigid mineral wool insulation was installed outside the sheathing. Hours per year when conditions support mould growth on the inside face of the exterior sheathing were less than 1% in the analysis. Spray-foam insulation was installed in areas where the vapour barrier could not be reinstated. All of these techniques were aimed at increasing thermal resistance, reducing air leakage, and moisture penetration into the wall cavity, essentially reducing energy consumption and increasing resident comfort.

Figure 4: Discontinuous Poly Layer Between First and Second Floors

The vapour barrier was repaired by sealing holes and providing additional polyethylene where it was missing, prior to any further remediation. Due to the complexity of the exterior wall construction, there was some limitation on the completeness of the repairs to the vapour barrier. New batt insulation (RSI 3.5) was then installed between studs.

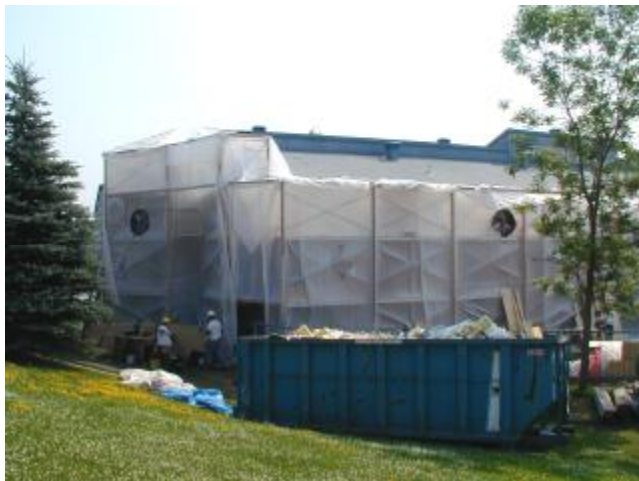
Figure 5: Tarp Enclosure

In order to ensure that the exterior work area was negatively pressurized relative to the interior of the Lodge, each elevation was completely enclosed with scaffolding and a tight tarp enclosure. Large fans through this tarp enclosure operated continuously, creating the negative pressure required to prevent any contaminants from entering the building interior (Figure 5). The interior polyethylene and drywall were maintained during all exterior repairs to keep a defined, exposed separation between exterior and interior. The enclosure also protected the exposed wall construction from rain and extreme temperatures. In instances where the

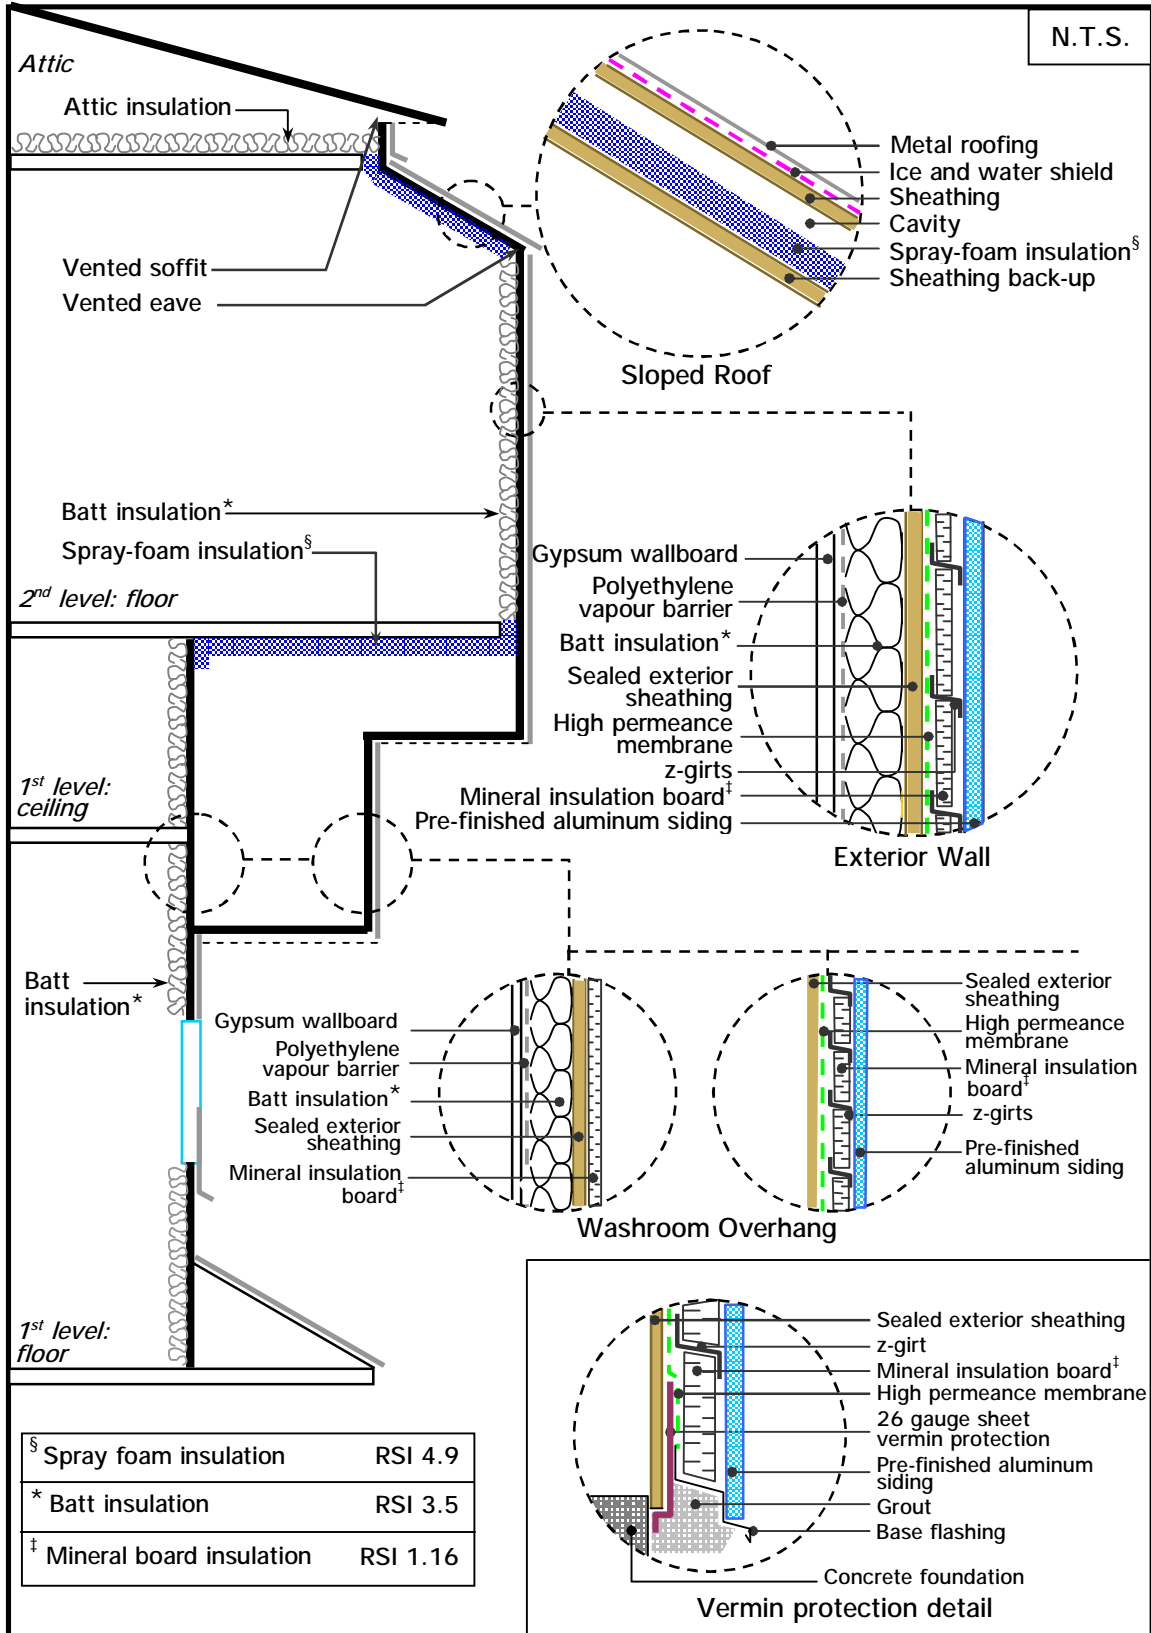
Figure 6: Schematic of Building Section and New Cladding System

For reference purposes, Figure 6 provides a schematic of a building section illustrating the newly constructed cladding system.

Vermin protection in the form of a 22 gauge L-shaped galvanized steel sheet 300mm in height was fastened to the sheathing at the base of the wall, and sealed with grout at its base (Figure 6).

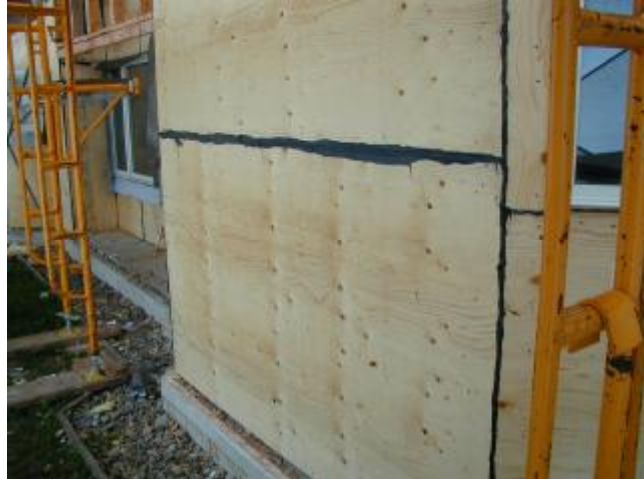
Figure 7: Sealed Joints in Sheathing

The Ontario Building Code (OBC) requires a gap to be provided between sheets of sheathing for new construction. The gap between plywood sheathing boards was sealed with acoustic sealant to the full depth of the edges (Figure 7). Where the acoustic sealant did not appear to fill the entire sheathing joint depth, the joint was taped to maintain the seal. In this way, the sheathing would be the primary air barrier for the building envelope with structural integrity to withstand the pressures developed across the air barrier. Sheet type air barriers can tear or become loose over time. However, since a moisture barrier was needed, and to provide redundancy to the air barrier system, a vapour permeable sheathing was installed over the plywood sheathing and clamped in place with z-girts (Figure 8).

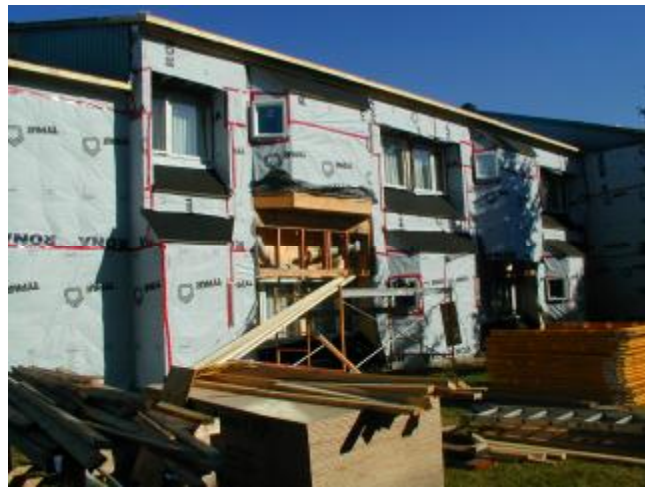
Figure 8: Tyvek Installed Over Sheathing

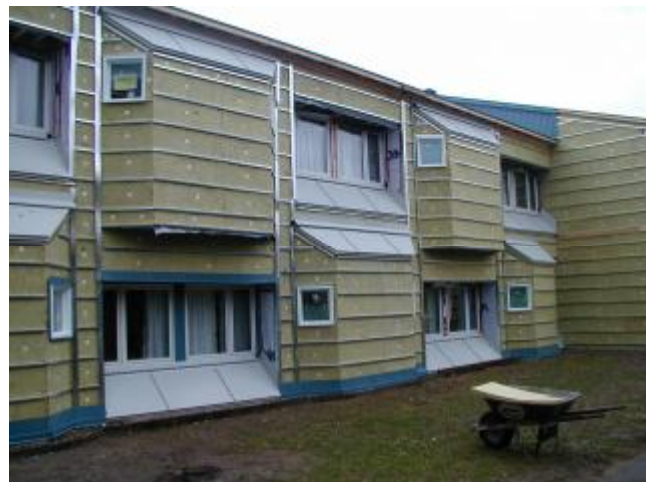
Figure 9: Installation of Rigid Insulation

Next, horizontal galvanized z-girts were installed with a slight slope away from the wall to drain any water away from the wall surface. Rigid mineral insulation board (RSI 1.16) was anchored to the sheathing between the girts to provide a more continuous thermal barrier against heat loss and reduce condensation within the stud cavity (Figure 9).

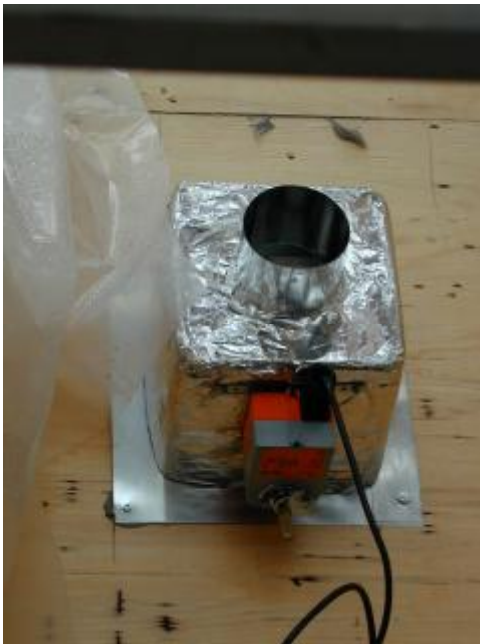
Figure 10: Installed Damper

the integrity of the air barrier, the dampers were sealed with acoustic sealant to the plywood sheathing, and mechanically fastened around their flanges (Figure 10).
