Case Study: Carleton Lodge – Recladding for a Better Environment

Tom Sinclair, P.Eng – Halsall Associates Limited
Ashok Malhotra, P.Eng. – Halsall Associates Limited
Brea Williams, Ph.D, P.Eng. – Halsall Associates Limited

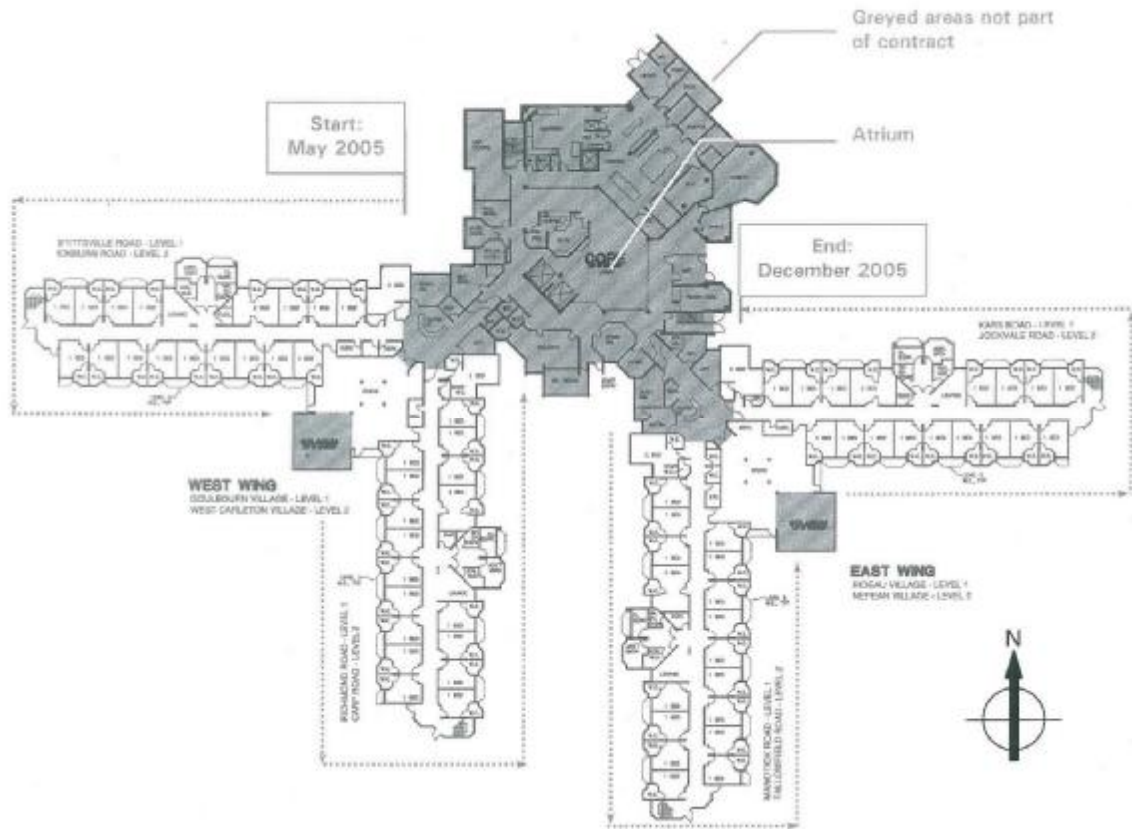
Figure 1: Building Plan

Carleton Lodge has a three-storey central core, with a large central atrium and a fourth level mechanical room. The central core is a reinforced concrete structure with insulated steel stud or concrete block exterior walls. Connected to the central core are long 2-storey multi-unit residential wings that are denoted “West” and “East”, as shown in Figure 1. The residential

Exterior cladding reconstruction was only performed on the wood framed residential wings of Carleton Lodge. The central core and two solarium areas, shown in grey in Figure 1, were not part of the contract. The central core houses the administration offices, kitchen, dining rooms and gathering areas for the residents. Reconstruction was conducted commencing at the North Elevation of the West Wing, and progressed counter-clockwise around the building, ending at the North Elevation of the East Wing. The exterior work was completed within a seven-month period from May 2005 to December 2005.
