# Assessing the effect of attic moisture in wood framed multi-unit row housing blocks.

Rene R. Boucher

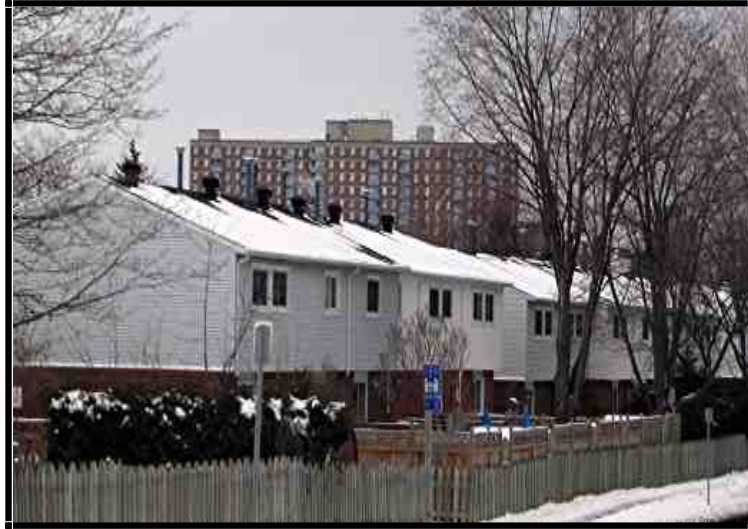
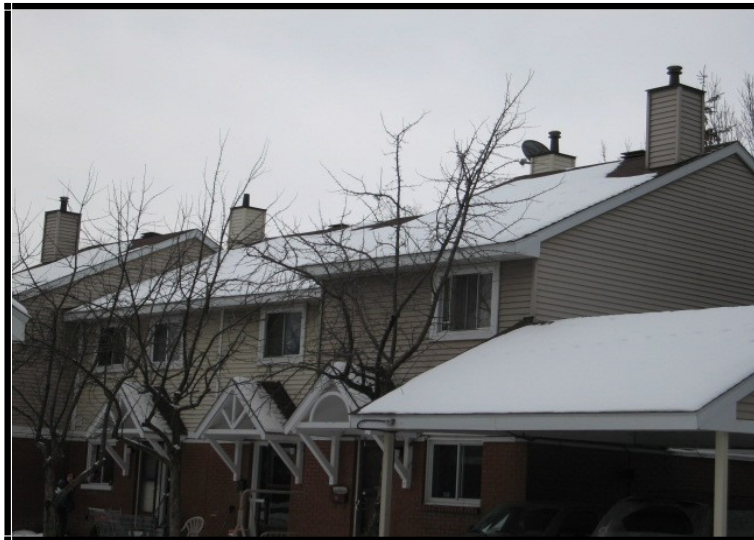
be a serious problem. It arrives from two directions: from the inside of the house as warm air rises and condenses on the underside of the roof deck and from the outside as water leakage through failed shingles, or from underneath the shingles as melted snow backs up as a result of ice damming at the eaves, and building offsets due to elevation and grade changes. In addition to water damage, any moisture in the attic can be the start of a serious mould and roof deterioration problem – dangers both to your health and to your investment.

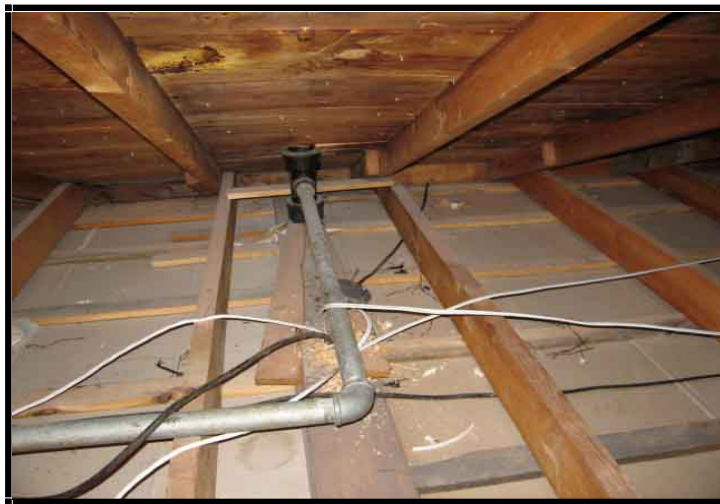
Unknowingly, the roofing industry was making the wet-attic situation worse. How? They were following the correct procedure for ventilation, but solving only part of the problem instead of the whole problem. Ventilating a previously unventilated attic has the effect of making the attic colder. If nothing is done to stop warm, moist air from entering the attic space from the living space, condensation on the now-cooler surfaces is a certainty. Mold, mildew, and eventually leakage into the living space will probably follow. Insulation contractors, armed with the same lack of information about attics as the roofers, have caused similar problems. Insulating the attic floor makes the attic colder in the same way as adding ventilation. But, if contractors don't seal as well as insulate, they don't stop warm, moist air from entering the attic and causing big problems.
